Rannamae, Eve, Andrianov, Vladimir, Järv, Eha et al. (3 more authors) (2019) A month in a horse's life : healing process of a fractured third metatarsal bone from medieval Viljandi, Estonia. *International Journal of Paleopathology*. pp. 286-292. ISSN 1879-9817

A month in a horse's life: healing process of a fractured third metatarsal bone from medieval Viljandi, Estonia

Abstract

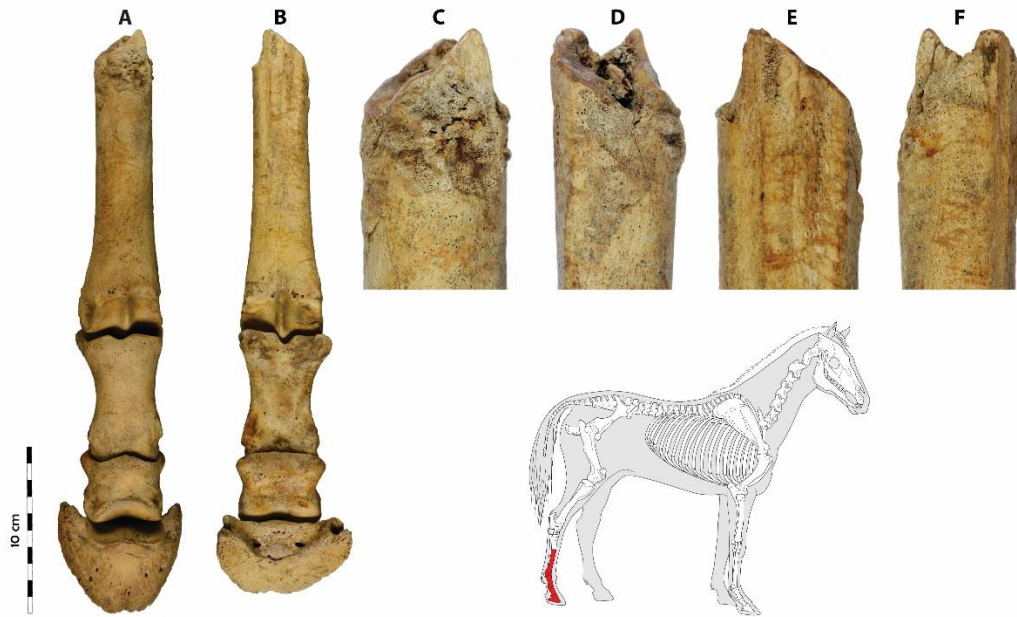
Figure 2. Four horse bone specimens of the right hind leg (marked red on the skeleton) in the medieval assemblage from Viljandi from **A)** dorsal and **B)** plantar view; and a close up of the fracture from **C)** dorsal, **D)** lateral, **E)** plantar and **F)** medial view. Photos and figure: E. Rannamäe, A. Haak; skeleton template by ©ArchéoZoo.org.

Size and shape. Visual comparison and the co-occurrence of all four bones in a single shallow pit indicate that they all belonged to a single individual. Based on the elongated hoof, round cross-section of the cannon bone, and wider medial articular surfaces of the phalanges, the remains were determined to be from a right hind leg (Figure 2A–B). Based on an overall size, bone structure and presence of fused epiphyses, the individual appears to be an adult of at least 15 months of age (Chaix & Méniel 2001).

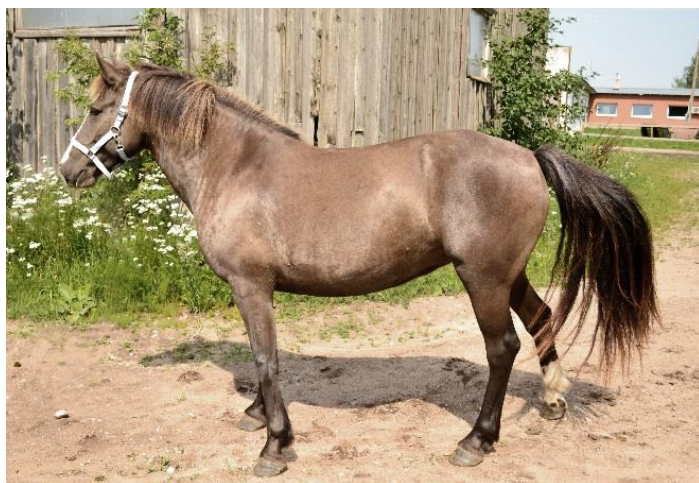
Figure 3. Estonian native horse. Withers height 145 cm, pectoral girth 173 cm (ARIB), estimated weight around 420 kg (after Saastamoinen 2011, 57). Photo: E. Rannamäe.

To assess the height of the horse, we compared the specimen to a similar size skeletal hind leg of a modern-day Estonian native horse. Withers height of the native horse (Figure 3) can vary between 129–151 cm (Niilo 1936, 8; Teinberg *et al.* 1995, 68), and weight can be between 266–505 kg (Niilo 1936, 8–10; Saastamoinen 2011, 57). Our calculations showed the medieval horse to have been approximately 128–136 cm high in withers and to have weighed around 360–390 kg (Table 1). This coincides with other osteological data from medieval Estonia, where the height of horses has been estimated to be 112–144 cm (Maldre 1998; Rannamäe & Lõugas in press).

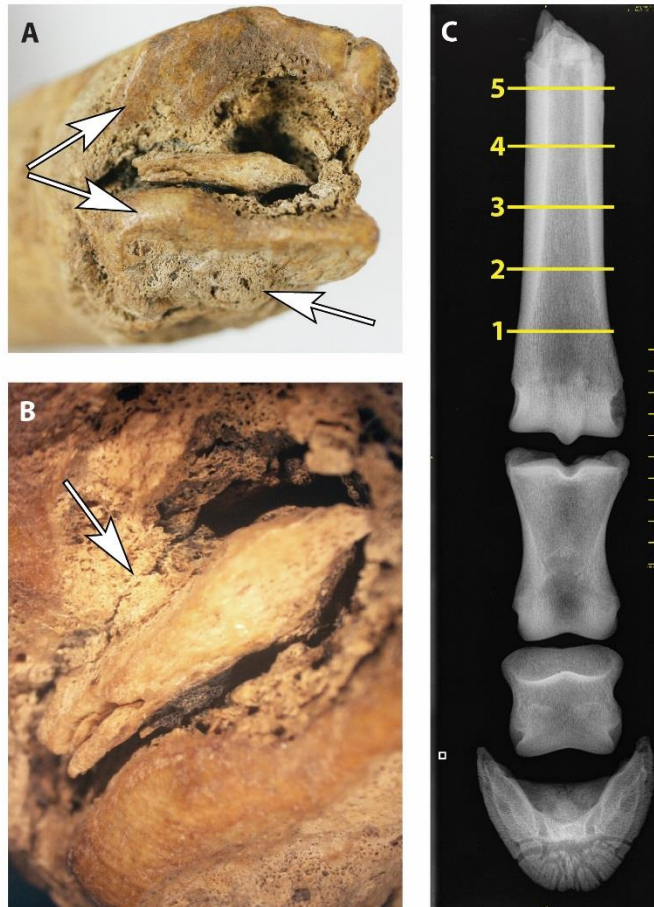
Figure 4. **A)** Ossification of the fracture. A newly formed callus is visible on the plantar surface of the bone (marked with lower arrow) and in the cavity, while edges of the separated diaphysis appear polished (marked with upper arrows). Photo: E. Rannamäe. **B)** The bone splinter attached to the bone cavity with newly formed bone tissue (100 × microscopic magnification). Some time during the post-mortem process the splinter has mechanically broken loose, indicated by a crack on the plantar side of the splinter (marked with arrow). Photo: E. Järv. **C)** Radiogram of the four specimens from dorsal view, and the locations (1–5) of densitometric measurements (see Table 2). Photo: A. Semjonov.

Radiographic analysis confirms the macroscopic observations and shows the formation of callus on the external side of the bone and around the bone fragment in the cavity. Otherwise the bone appears to be healthy with normal thickness throughout the bone (Figure 4C), as also confirmed by the densitometric measurements (Table 2). The bone mineral density was shown to be similar between the third metatarsal bones of the medieval and modern individual. Measurements indicate that the medieval individual did not have any predispositions to fractures (*e.g.* osteoporosis or some inherent metabolic disorder) and could be considered a healthy animal.

Table 2. Bone mineral density (BMD) of the third metatarsal bone of the medieval and modern reference individual. For the locations where measures 1–5 were taken, see Figure 4C.

It is worthwhile to note that a simple splint would not have been sufficient to enable healing for one month without the animal laying down and risking re-injury. Therefore, a use of some sling is likely (Figure 6). This method of treatment has been used since at least the 19th century (von den Driesch & Peters 2003, Abb. 8-3), but to our knowledge, there is no such evidence from medieval Livonia. Being in a sling does not allow the animal to make any active movements, but it does not keep it from passive movements or from putting some pressure on the leg (the probable cause for the fused bone splinter). These passive movements are suggested by the heavily polished extremities of the diaphysis and by small sections of the callus that have been worn down (Figure 4A).

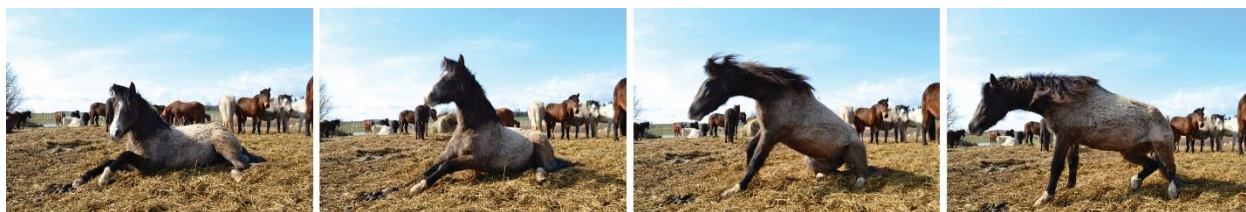
Figure 5. Estonian native horse getting up from prone position. Note that just before standing up, the whole body weight lies on hind legs. Photos: E. Rannamäe.

Horses are not as flexible animals as dogs or cats. To get off the ground from a lying position, a horse must lean on its hind legs, putting its whole body weight on them (Figure 5). This kind of pressure would most probably have torn the skin near the fracture, leading to an infection and death in a few days. However, as stated above, the bone fracture seems to have been closed and stable with no apparent infection, allowing the horse to survive for around a month. It has been suggested that a horse can stand on its four legs for two weeks or even more without signs of heavy fatigue (Reidla 1995, 328), but in the current case the horse had only three legs to use. Thus, spontaneous healing on a pasture or in a stall is unlikely, as moving around or standing for a whole month without wanting to lie down could hardly have been possible.

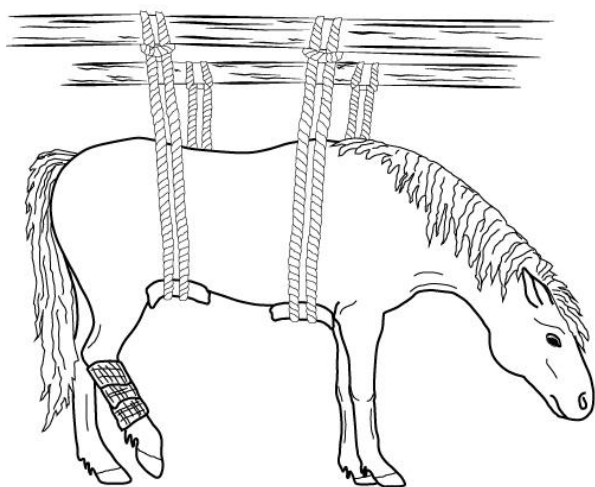
Figure 6. Horse in a sling. Figure composed by E. Rannamäe and E. Järv (modified after von den Driesch & Peters 2003, Abb. 8-3; Reidla 1995, Fig. 113).
